Building Inspection Report

1000 Pike ST NE Auburn WA 98000

Inspection Date:
6/11/2011

Report Number:
111092
ICN
9282BA030

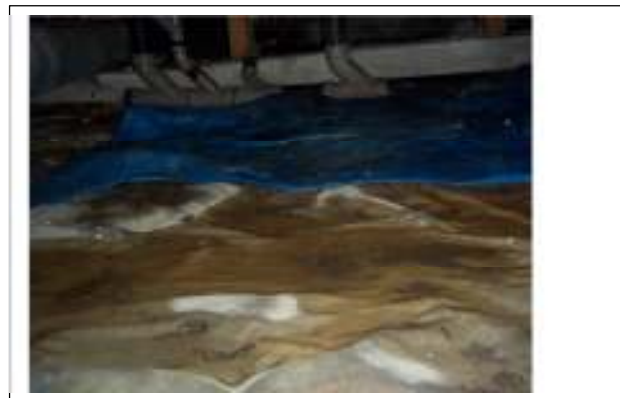
Crawl Space

- **Repair:** Standing water was observed in the crawl space. Wet crawl spaces risk building damage from rot and insects and can cause interior mold or mildew. Roof and lot drainage repairs or improvements should be addressed as a first step to controlling water in the crawl space (see "Exterior"). This condition should then be monitored to determine if additional, potentially costly measures are necessary. See Plumbing Section for additional information.

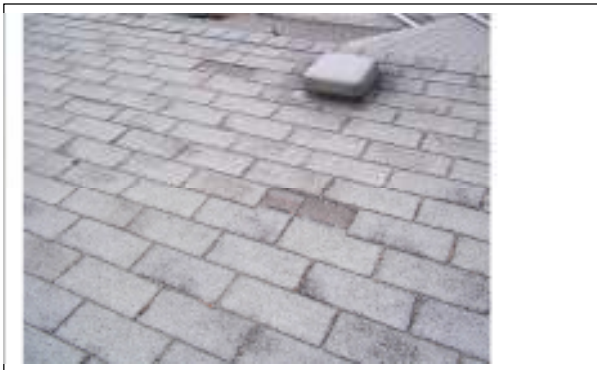
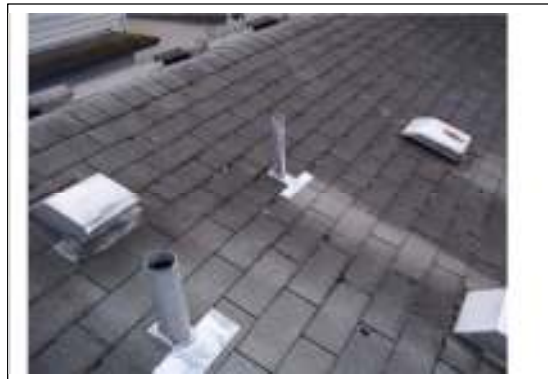
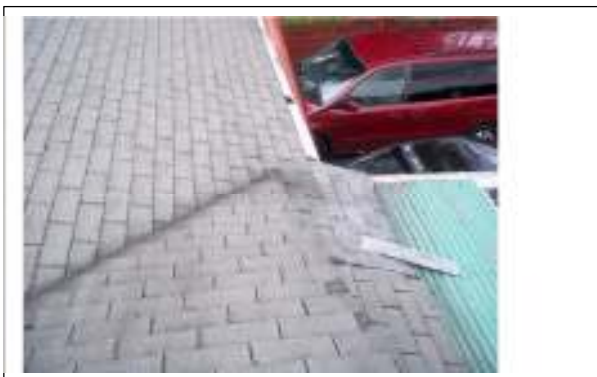
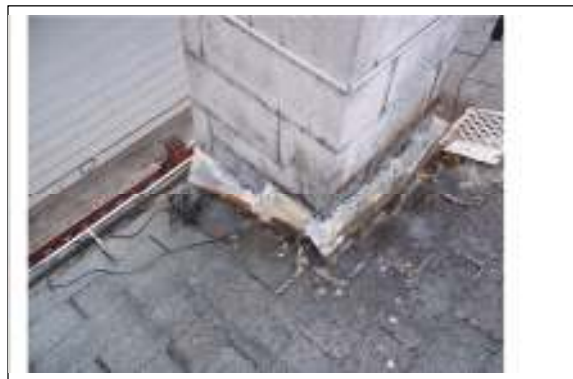
Sloped Roofing

- **Major Concern, Repair:** The roofing is at end of life and should be replaced. Vulnerable areas noted.

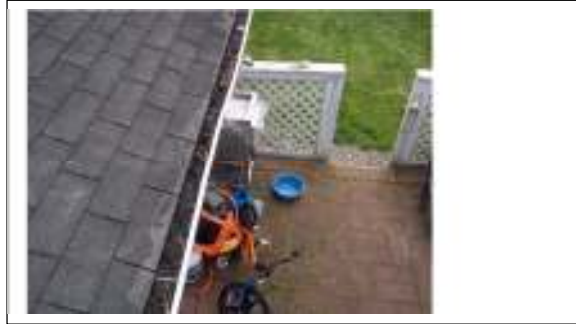
Gutters & Downspouts

- **Repair:** The gutters require cleaning to avoid spilling roof runoff around the building – a potential source of water entry or water damage. Minor repairs needed to assist water away.

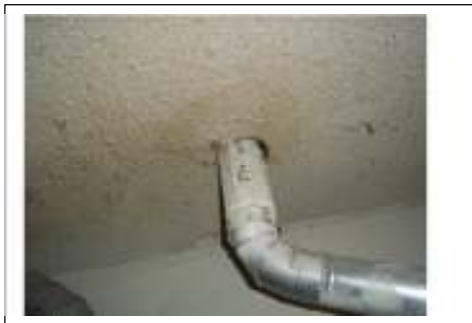
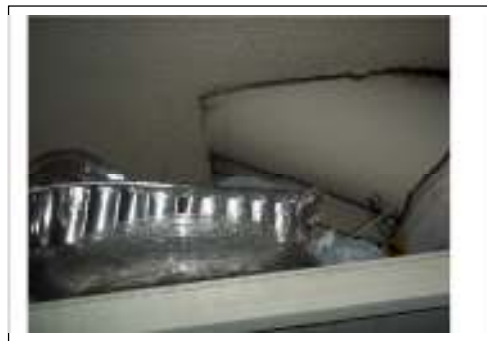
Garage / Shed Storage

- **Repair, Safety Issue:** Proper fire separation between the garage and house proper is recommended at the HVAC duct through ceiling. Additionally several holes are observed throughout garage ceiling that are in need of repairs.

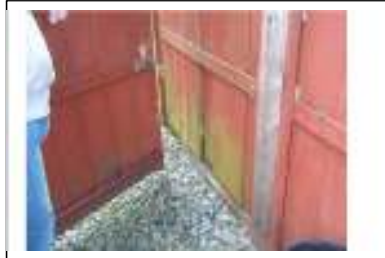
Fencing

- **Repair:** The gate and latch mechanism needs adjustment to function properly. South side.

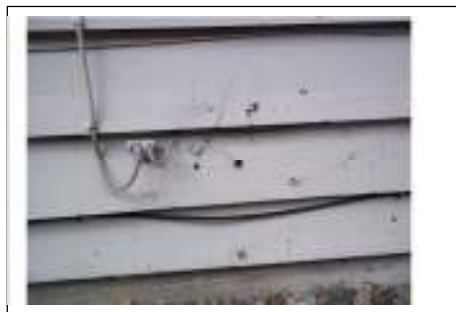
Exterior Walls

- **Repair:** several holes are noted in exterior walls from utilities etc. recommend a full examination of the exterior and repair as needed.

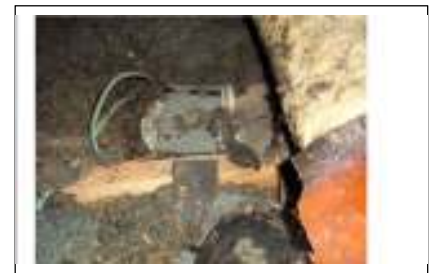
- **Monitor:** Insulation and roof ventilation improvements may be cost effective, depending on the anticipated term of ownership.
- **Repair:** Disturbed insulation should be repaired or evened out.

- **Improve:** The level of ventilation is marginal. It is generally recommended that one (1) square foot of free vent area be provided for every one hundred and fifty (150) square feet of ceiling area. Proper ventilation will help to keep the house cooler during warm weather and extend the life of roofing materials. In cold climates, it will help reduce the potential for ice dams on the roof and condensation within the attic.

- **Repair:** The passage of air between the soffit vents and the roof cavity appears to be obstructed. “soffit vents” should be provided and allow for free movement of air within the roof space. This area should be further investigated and improved where necessary.

- **Repair:** Exhaust vent pipes from the bathroom(s) should be vented to the building exterior. Insulation should be provided on exhaust vent pipes.

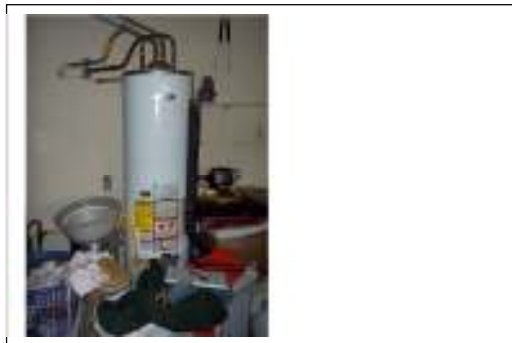
Water Heater

- **Repair:** Water heaters in seismic zones should be anchored or strapped to resist movement during earthquake conditions.
- **Improve: Safety Issue: Repair:** Given the location of the water heater, it should be better protected from physical damage. Protection from automobile contact.
- **Repair, Safety Issue:** Water heaters in garages should be on a raised platform so that the pilots, burner or heating elements are not closer than 18 inches from the garage floor.
- **Repair:** The stand under the water heater does not appear to adequately support the tank safely. Rebuilding or modifying is recommended.

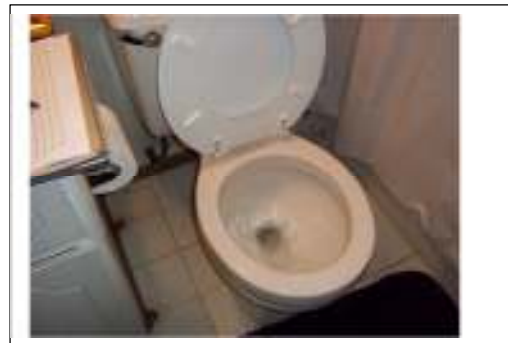
Fixtures

- **Monitor:** The majority of plumbing fixtures are old.
- **Repair: Monitor: Possible Major Concern:** The floor adjacent to the toilet shows evidence of water damage. High moisture readings surrounding the toilet extending to the tub and below the vanity, further investigation required to determine the extent of repairs, all damaged and hidden damage must be removed and replaced, the area should be thoroughly dry prior to re-covering, re-inspection is recommended prior to re-cover to determine if additional repairs or treatments are necessary prior to re-covering.
- **Repair:** Evidence of water damage to the floor adjacent to the bathtub enclosure was observed. The extent of damage is difficult to predict without removing floor coverings.
